# Manhole Inspection Summary

Manhole # S31I\_\_028MH

**Location** Address: **Emory St**

Cross Street: **Dover St**

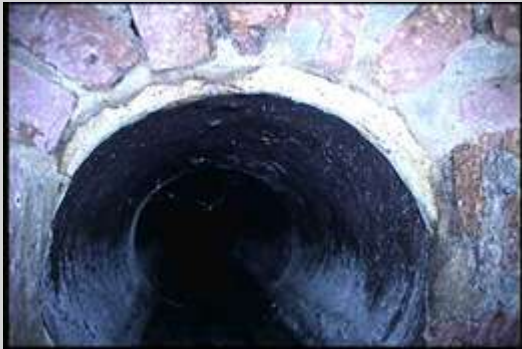
12 O'Clock Outflow

10 in. Circular Gravity Sewer  
Pipe Out @ 12 O'Clock

Pipe Height: **10.8** (in.) Rod and Bar (Angled)  
Pipe Material: **Clay** ☐ Pipe Lined  
Invert Depth: **13.89** (ft.) Flow Characteristics: **Slow**  
Deposits: ☒ None ☐ Mud ☐ Sludge ☐ Debris ☐ Grease  
Silt Depth: **0** (in.) Deposits Extent:  
Infiltration: **None** Pipe Seal Cond: **Sound**

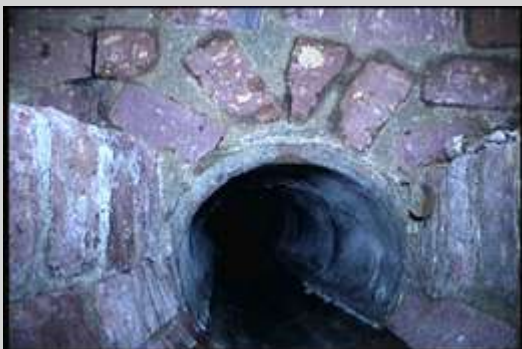
4 O'Clock Inflow

8 in. Circular Gravity Sewer  
Pipe In @ 4 O'Clock

Pipe Height: **8.4** (in.) Rod and Bar (Angled)  
Pipe Material: **Clay** ☐ Pipe Lined  
Invert Depth: **13.80** (ft.) Flow Characteristics: **Fast**  
Deposits: ☒ None ☐ Mud ☐ Sludge ☐ Debris ☐ Grease  
Silt Depth: **0** (in.) Deposits Extent:  
Infiltration: **None** Pipe Seal Cond: **Sound**
